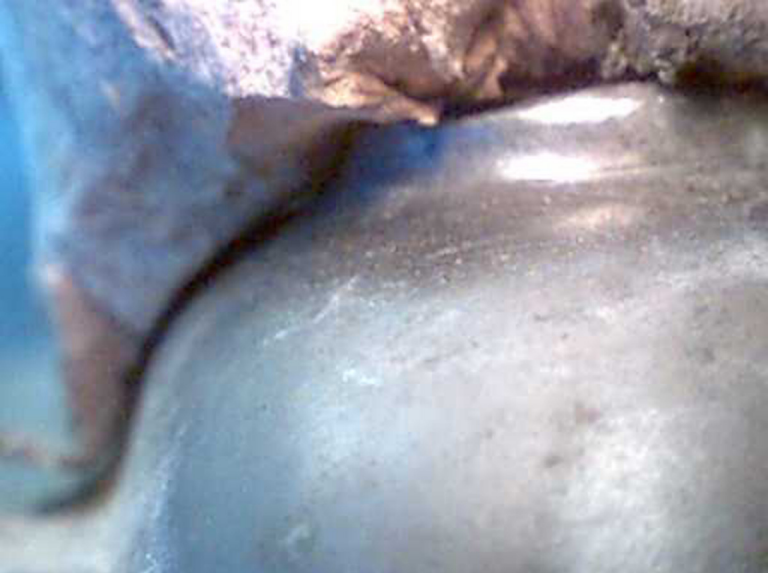
Photo #6: Close-up view of point of contact between victim and hubcap. Stem tissue at top, metal of hubcap below (10x).
